Evaluation of extreme load performance of pre-Northridge connections

Scientific paper - Preliminary note

Iman Faridmehr, Mohd Hanim Osman, Mamood Md. Tahir, Ali Farokhi Nejad, Reza Hodjati

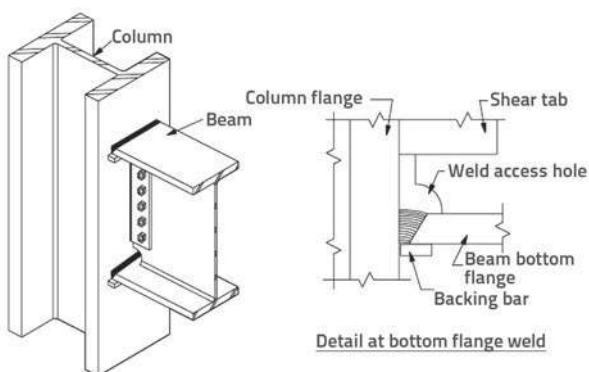
Figure 1. Typical Pre-Northridge welded flange - bolted web moment connection

After the Northridge earthquake, damage reports indicated that prevalence of bottom flange weld fractures in the absence of inelastic beam deformations was evident in the pre-Northridge connection (Figure 1). From an economic point of view, the Northridge Earthquake of 1994 was very costly, and it caused millions of dollars of damage to the building industry.

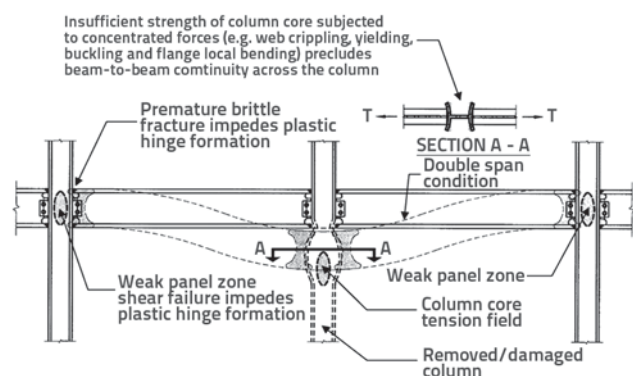
Figure 2. Inability to protect against progressive collapse after loss of column, GSA [19]

There is an old perception in the structural engineering community that seismically designed structures, such as moment and braced frames, have better resistance to progressive collapse. In other words, there is an implicit assumption that the seismic design and detailing will lead to an enhanced resistance to progressive collapse. In fact, due to lack of design guidelines for progressive collapse, the seismic design is frequently advocated by researchers and practitioners for cases in which prevention of progressive collapse is a design objective, while there is no systematic study to date that would show how the seismic design and detailing influences a structural system's behaviour in a progressive collapse situation. This is an important issue that has to be addressed because seismic forces impose a very different type of demand on a structure, when compared to collapse. For example, the moment frame seismic forces end up in high moment demands in the connection region. However, collapse is associated with high tensile forces, which may adversely influence the performance of seismically designed connections. In a column loss event, the catenary action of beams is highly dependent on the characteristics of connections, as illustrated in Figure 2. Up to now, no sufficient documents have been obtained to reveal that pre-Northridge connections possess sufficient robustness to permit development of plastic rotations at beam ends together with large tensile forces. Therefore, the behaviour of this type of connection under collapse leads to an open issue that requires thorough analysis before such systems could be recommended for progressive collapse scenarios.

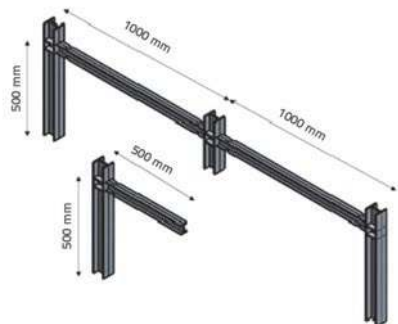
Figure 3. Case studies for seismic and progressive collapse assessments

The case studies of this research involve two 1/6th-scale beam-to-column connections incorporating I shaped cross-sections subjected to cyclic and push-down tests. The frames were designed according to the requirements contained in the "Specification for Structural Steel Buildings (ANSI/AISC 360-10) [9]. Details of the proposed connection for seismic and progressive collapse assessments are shown in Figure 3 and Table 1.

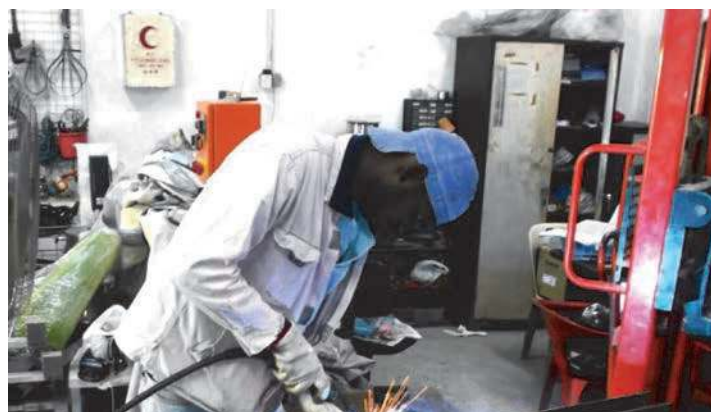
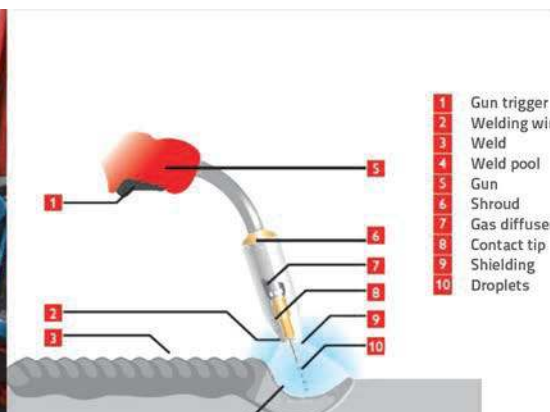
Figure 4. View of welding transfer and accessories

The fabrication of test specimens was conducted through collaboration of the university laboratory personnel and commercial fabricators. The Gas Metal Arc Welding (GMAW) process was used in this study. The GMAW, commonly known as the Metal Inert Gas (MIG), is a group of arc welding processes in which powered feed rolls (wire feeder) feed a continuous electrode (the wire) inside the weld pool (Figure 4). By the time the welding process commences, an electric arc is made between the weld pool and the tip of the wire. The melting of the wire is operated in a progressive manner at the same rate at which it is being fed and consequently, the weld pool is implemented. For simultaneous protection of the weld pool and arc against atmospheric contamination, a nozzle concentric with the welding wire guide tube is incorporated to convey a shield of inert (non-reactive) gas. The speed, comparative freedom from distribution, continuity and reliability of automatic welding, as well as the control and versatility of manual welding, are listed as the advantages of this type of welding application. The incorporation of this technique in mechanized set-ups has been rapidly accepted. A handheld gun was used to successfully perform the MIG welding as a semiautomatic process. Since the voltage, speed, arc (stick-out) length, and wire feed rate set to plate thickness, are listed as

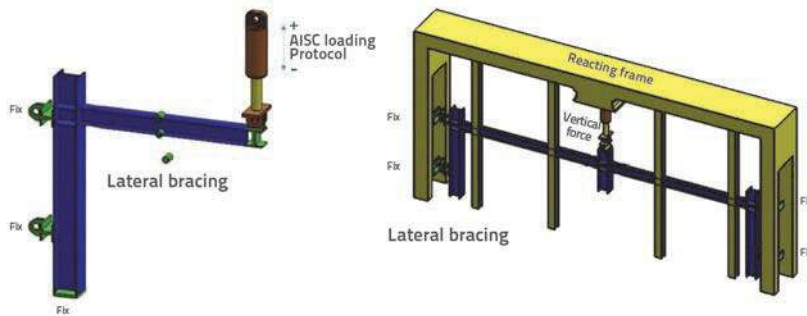
Figure 5. Modelling set up for seismic and progressive collapse assessments

The seismic and progressive collapse performance of the 1/6 scale testing specimens was assessed using different loading protocols and lateral restraint assemblies (Figure 5).

The missing column scenario (Alternate Path method) was incorporated as the progressive collapse test method for this study where an instantaneous disastrous event was supposed to destruct the interior column of the structure. In the Alternate Path method, the vertical load was gradually increased using the hydraulic jack on top of the missing column, as shown in Figure 6. Both sides of the beams were laterally restrained at 150 and 800 mm away from the centreline of the specimen column. A 250-KN hydraulic pseudo-dynamic actuator with a maximum piston stroke of 500 mm to the tip of the beam was chosen to conduct and evaluate the cyclic test of the specimens (Figure 6). The middling length of beam from the centreline of the specimen column was the location of lateral restraint of both sides of the beams. A number of strain gauges were installed at predictive hinge locations of steel beams, usually at beam ends, to measure internal forces of the specimens. Linear Variable Differential Transducers (LVDTs) were used to ensure an accurate measurement of vertical deflection of the specimen at the location of the removed column and tip of the beam. In addition, the following assumptions were made in this study:

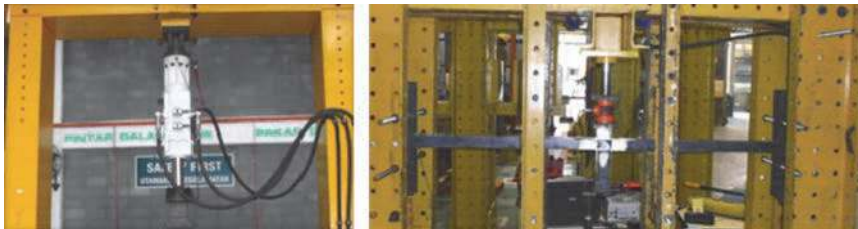
Figure 6. Dynamic actuator and hydraulic jack used for seismic and progressive collapse evaluations

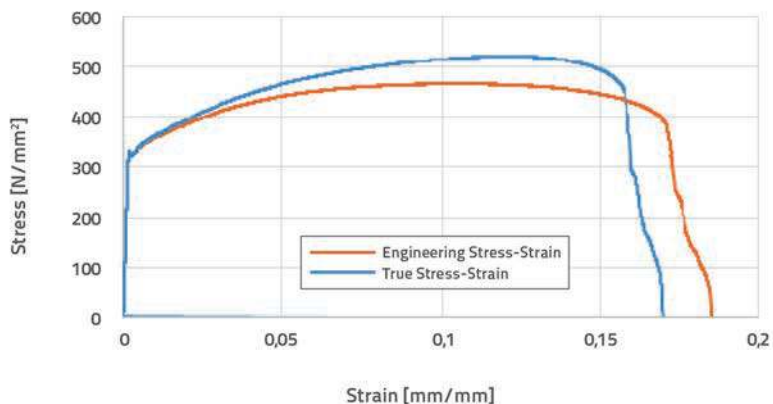
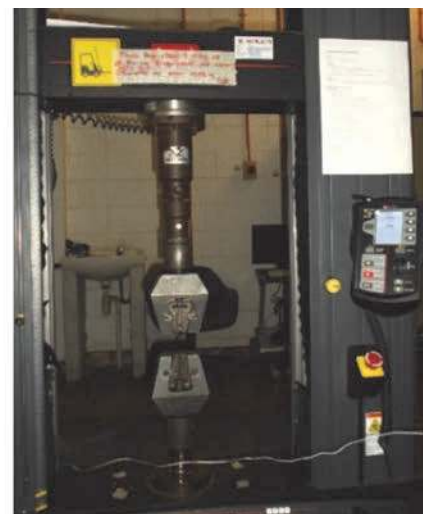
Figure 7. Material properties for true stress-strain and engineering stress-strain curves (left), universal testing machine (right)

where σ and ε are the true stress and strain values determined from equations 6 and 7, while e and S are the engineering strain and stress values, respectively, as obtained from the uniaxial tensile test (equations 4 and 5). True and engineering stress-strain curves, and the universal testing machine used in the testing, are shown in Figure 7.

The yield stress, ultimate tensile strength, and elongation values obtained during the tensile strength testing amounted to 320 MPa, 510 MPa, and 18 %, respectively. Material properties of the sheet steel plate used in this research are similar to Grade 50 according to American standard ASTM A572-07. Notice that this grade is equivalent to European standard S420M/EN 10025-4. In all the FEA cases, and at all degrees of freedom, the column base was fixed and the load was applied by controlling displacement in vertical directions. The quasi static loading at the rate of 2mm/s was chosen for the testing. The hex element

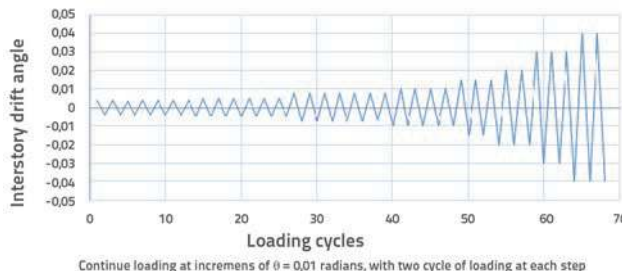
Figure 8. Loading protocol used for seismic assessment

The 2010 AISC Seismic Provisions [9] were considered in selecting the loading sequence for this study. The series of load steps, and the number of cycles needed for each step, are specified in the AISC Protocol (Figure 8). Each load step corresponds to the total interstorey drift angle. The testing began by application of load steps, and by recording the data points at regular intervals. By the time each load step was completed, appropriate observations were recorded. The loading was stopped as soon as the strength of the specimen reduced to 40 percent of the maximum strength. On the other hand, the vertical push-down analysis was performed by gradually increasing vertical displacement at the location of the removed column in order to study the rotational capacity of the connection, and the structure’s resistance to this deformation.

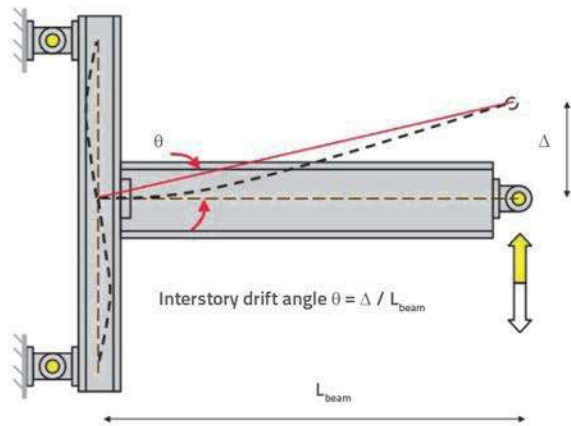
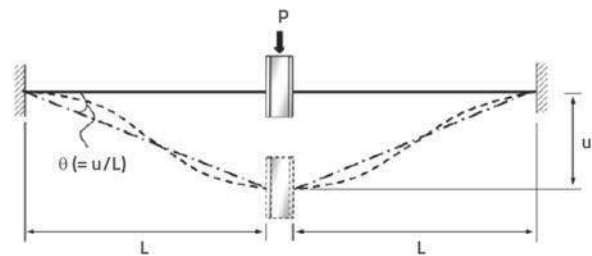
Figure 9. Definition of interstorey drift angle and connection rotation capacity

- The interstorey drift angle of at least 0.04 rad must be sustained by the connection (Figure 9).
- The flexural resistance of the connection calculated at the column face must be equal to at least $0.80 \cdot M_p$ of the connected beam at an inter storey drift angle of 0.04 rad, where M_p is plastic moment.

An adequate rotational capacity of connections is fundamental for the prevention of progressive collapse (Figure 9). Moment connections that have been prequalified for rotational capacity due to bending alone may not be able to concurrently resist the interaction of axial tension and bending moment, which is an essential performance attribute for preventing progressive collapse. While the tension stiffness ("cable-like" action) can significantly increase the load carrying capacity of the system over bending moment alone, the beam-to-column connection must be able to transfer the large flange tension forces developed from the combination of bending moment and axial tension. Table 5-2 from the UFC 4-023-03 [23] highlights the design strength and rotational capacities of the beam-to-column connections that

Results of the FEA and experimental phases of this study are presented in this section. The main variable in the assessment of the progressive collapse phenomenon is the plastic rotation angle (θ), which is defined as the vertical deflection of the column (u) divided by the clear span length of the beam (L) (Figure 9).

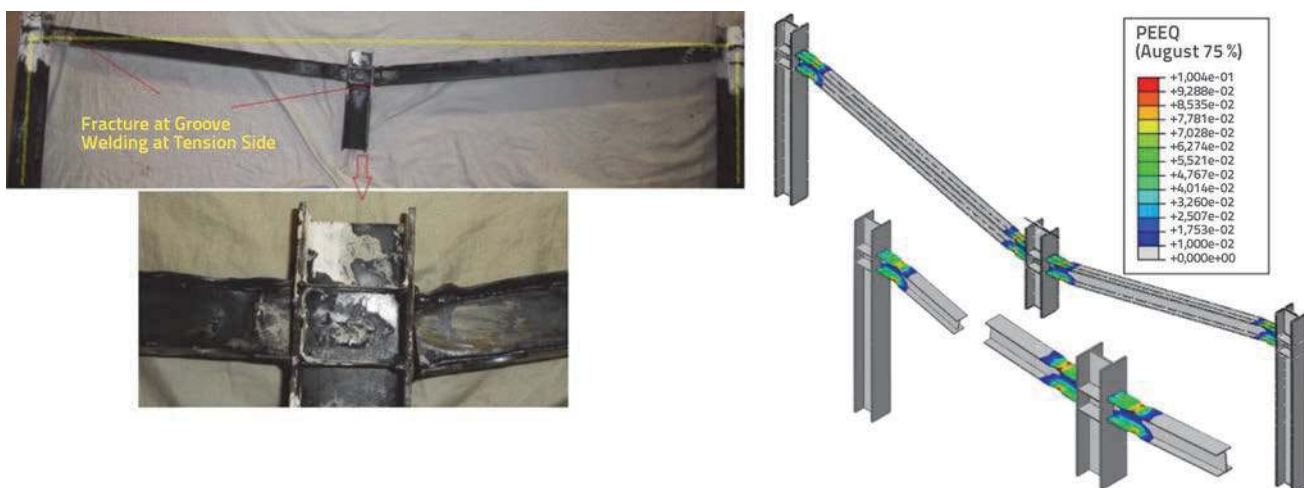
Figure 10. Specimen damage at the end of progressive collapse test and plastic equivalent strain distribution

The fracture of the groove welding between the beam flange and column face at the tension side of the beam, along with further propagation of the beam web cracking, was the governing failure mode according to experimental assessment. The specimen was capable of resisting the vertical load of 6 kN prior to initiation of the groove weld fracture. Strain gauges placed at the beam flange did not record strains higher than 1800 $\mu\epsilon$ (micro-strain), which pointed to the limited performance of the connection to develop catenary action. The connection resisted the plastic rotation angle of 0.015 rad prior to severe degradation and, therefore, the specimen did not meet the DoD guideline requirements [23]. The damaged state of the specimen, and the plastic equivalent strain distribution after the final stage of the progressive collapse test, is shown in Figure 10.

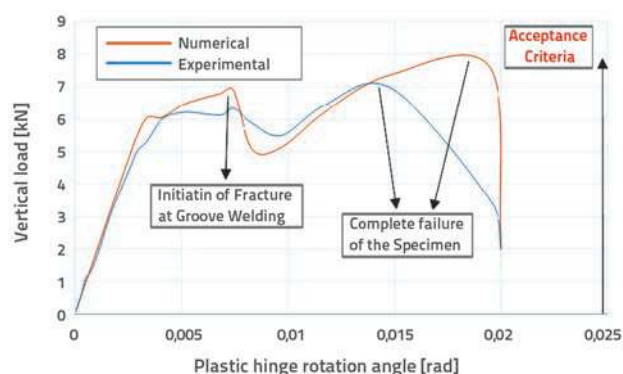
Figure 11. Vertical load vs. plastic hinge rotation angle for progressive collapse tests

The numerical and experimental visualized plots of vertical load, versus the plastic hinge rotation angle of the progressive collapse tests for specimens, are shown in Figure 11. According to Figure 11, there is a good correlation between the experimental and numerical results in terms of the yield point, strain hardening and mode of failure. However, there is an obvious difference for maximum plastic hinge rotations between the FEA and experimental testing. This shows that different behaviour of

welding in the numerical and experimental phase of the study is the cause of such difference in performance. Hence, it could be concluded that the performance of RBS connection was strongly dependent on the groove welding.

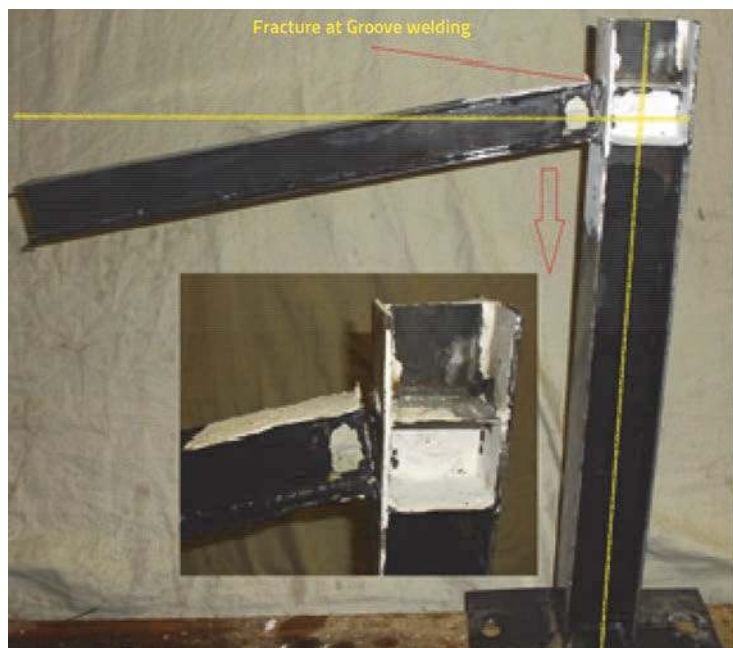
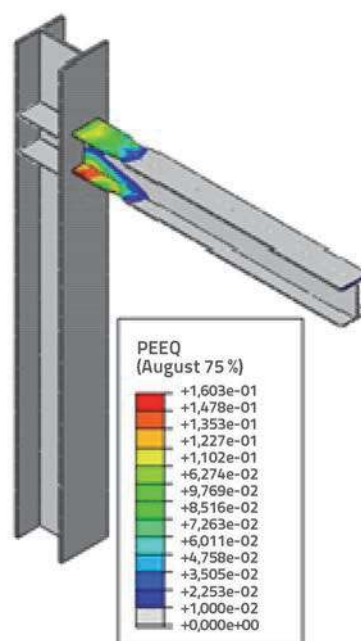
Figure 12. Specimen damage at the end of cyclic test (left), plastic equivalent strain distribution (right)

Seismic performance of connections is discussed in this section. The interstorey drift angle, considered as a fundamental parameter in the investigation of seismic performance, is shown in Figure 9. A poor specimen performance under cyclic loading was reported. Although it was anticipated that the plastic hinge will form at the beam, the welding fracture was the actual failure mode of the specimen. At the first stage of failure, the groove welding showed early or brittle fracture at an interstorey drift angle of 0.01 rad. Progressing through the loading history, the propagation of the weld fracture along the groove welds of the beam flange and the column face was initiated. During the cycle of 0.018 rad, an increase in the crack length of up to 1 mm was observed, which led to severe strength degradation. Strain gauges placed on beam flanges showed records lower than $1800 \mu\epsilon$ (micro-strain), which is an indication of limited performance of the connection to develop fully plastic capacity of the connecting beam. Specimen damage at the end of the cyclic test, and plastic equivalent strain distribution, are shown in Figure 12.

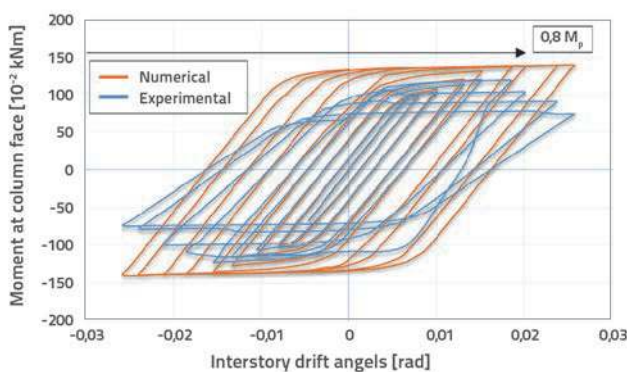
Figure 13. Moments at column face versus interstorey drift angles

Moments computed at the column face versus the interstorey drift angles, are recognized as the global cyclic response of the specimen shown in Figure 13. Numerical modelling and experimental testing results were in good agreement as to the overall cyclic behaviour.

Notice that the constitutive model for the material behaviour prediction was an elasto-plastic model, and the simulation was

continued until degradation by damage. Accordingly, stiffness degradation cannot be seen numerically in contrast with experimental testing, where stiffness degradation was related to the localisation of damage in the welding zone. Besides, numerical results also confirmed the formation of plastic hinges in the vicinity of groove welding. Therefore, the vulnerability of groove welds to probable fractures was increased.
